# HISTORIC RESOURCE INVENTORY FORM

Property name (if any): Robinson House tax id: 32.5-5-7  
Address or Street Location: 601 Bridge (Second Empire) Rural Fire Number: \_\_\_\_\_  
County: Fulton Town: Northampton Village/Hamlet: Northville  
Original use: Residence (year round) Current use: Residence (year round)  
Architect/Builder, if known: \_\_\_\_\_ Construction Date : \_\_\_\_\_  
Owner: William & Barbara Mosher

**Address:** 601 Bridge Street  
 Photo:

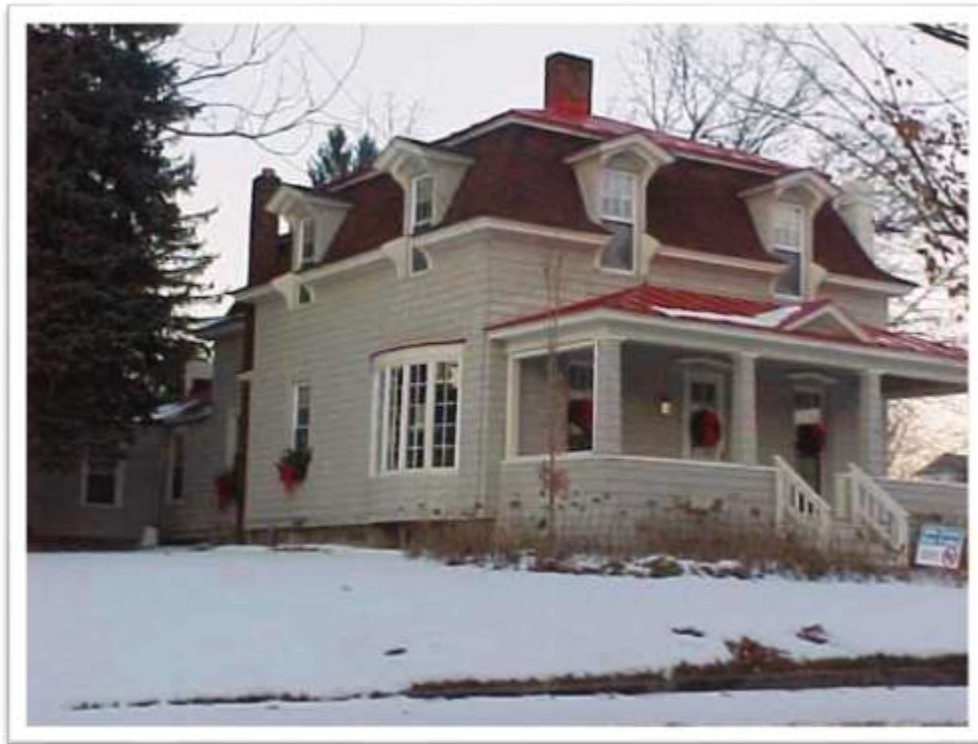
**South Elevation**

**Narrative Description of Property:** This 1 ½ story wood frame residence was built in the Second Empire style with a Mansard roof and dormered second floor windows that have triangular pediments. The first floor windows are hooded with a simple pediment. The windows are 6/6 dbl hung vinyl. The roof is metal on the peak and asphalt on the straight sides. The full front porch has a metal roof and simple center gable accent. The columns are square, tapered, and shingled. There is a rear addition that appears to be original according to the mapping and lithographs. There is also a rear bar/carriage house. There is a center brick chimney , a side concrete block chimney and a brick chimney on the rear wing (kitchen).

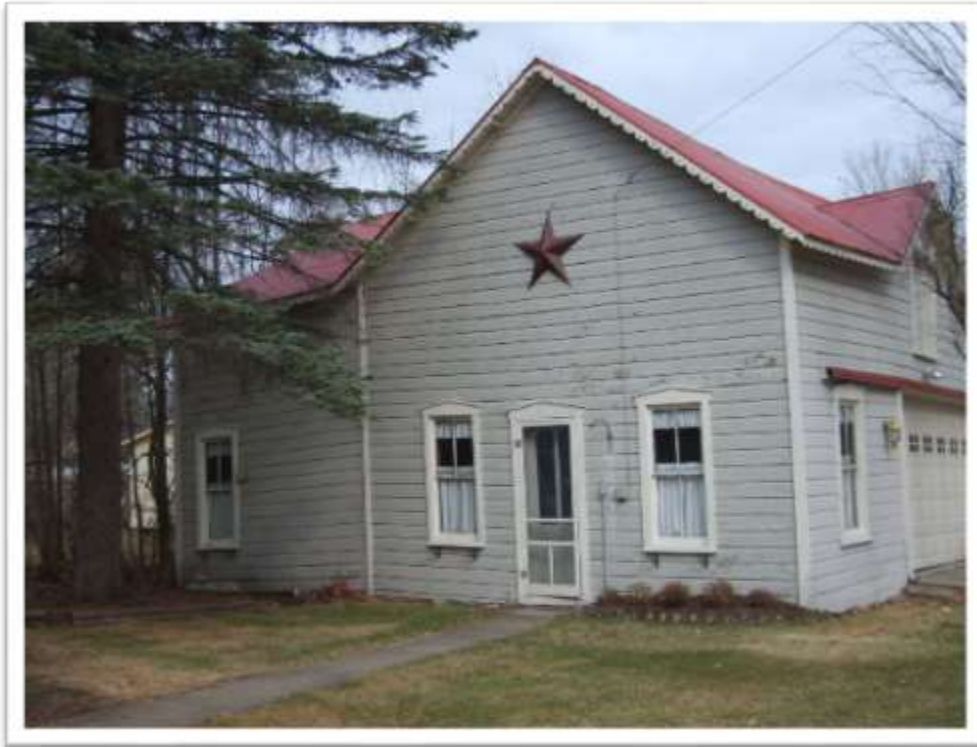
**Carriage Barn**

The barn/carriage shed has the original 2/2 wood windows. They are also hooded with a simple triangular pediment. The gable ends have had a simple Victorian verge board added.
