# HISTORIC RESOURCE INVENTORY FORM

Property name (if any): Robinson House tax id: 32.5-5-7  
Address or Street Location: 601 Bridge (Second Empire) Rural Fire Number: \_\_\_\_\_  
County: Fulton Town: Northampton Village/Hamlet: Northville  
Original use: Residence (year round) Current use: Residence (year round)  
Architect/Builder, if known: \_\_\_\_\_ Construction Date : \_\_\_\_\_  
Owner: William & Barbara Mosher

**Address:** 601 Bridge Street  
 Photo:

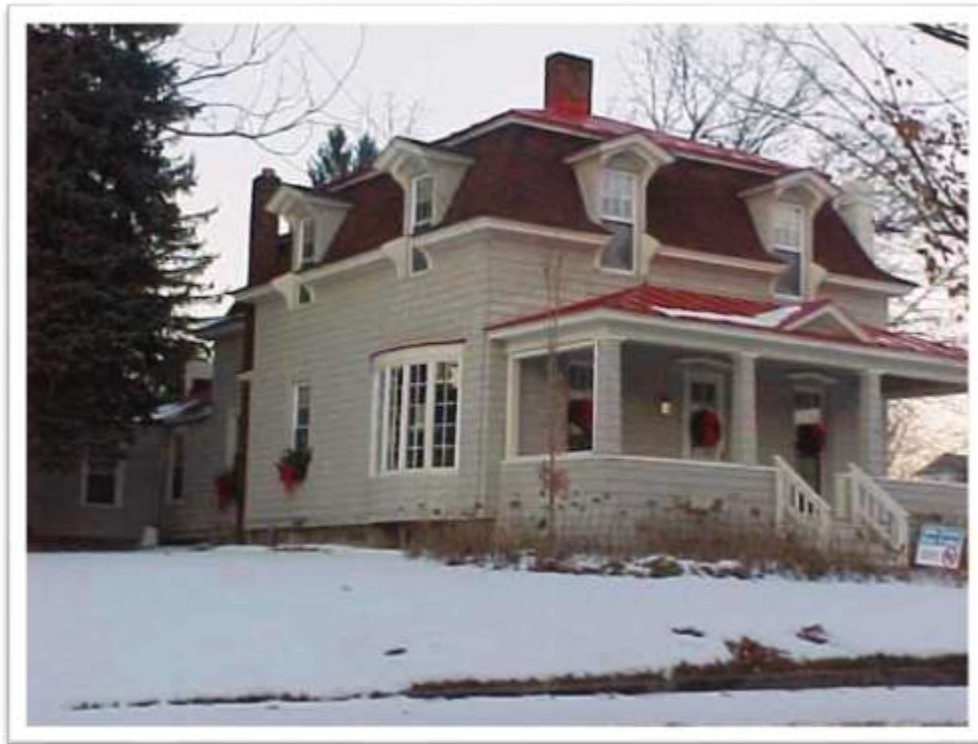
**South Elevation**

**Narrative Description of Property:** This 1 ½ story wood frame residence was built in the Second Empire style with a Mansard roof and dormered second floor windows that have triangular pediments. The first floor windows are hooded with a simple pediment. The windows are 6/6 dbl hung vinyl. The roof is metal on the peak and asphalt on the straight sides. The full front porch has a metal roof and simple center gable accent. The columns are square, tapered, and shingled. There is a rear addition that appears to be original according to the mapping and lithographs. There is also a rear bar/carriage house. There is a center brick chimney , a side concrete block chimney and a brick chimney on the rear wing (kitchen).

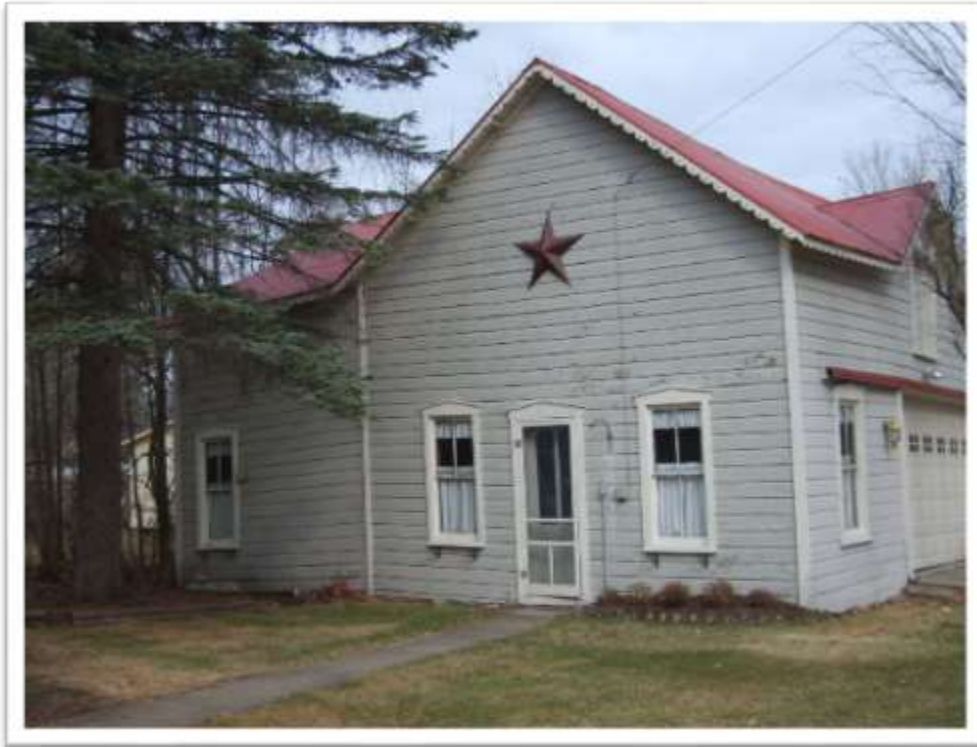
Carriage Barn

The barn/carriage shed has the original 2/2 wood windows. They are also hooded with a simple triangular pediment. The gable ends have had a simple Victorian verge board added.
